Project: African Union Old New York Office Maintenance

Location: New York, USA

Background

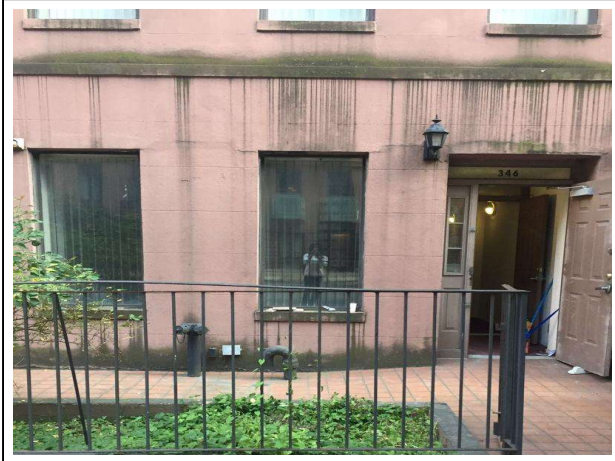
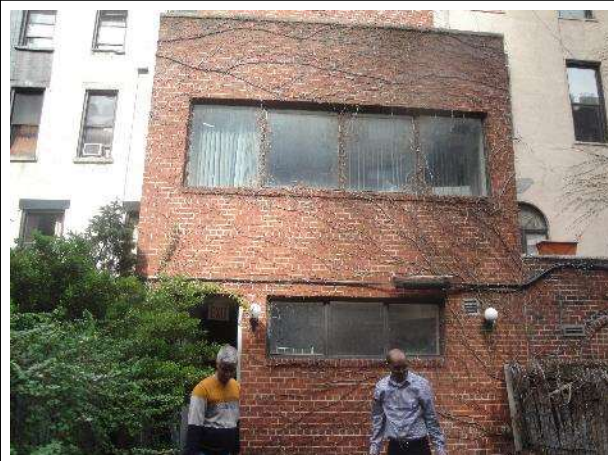
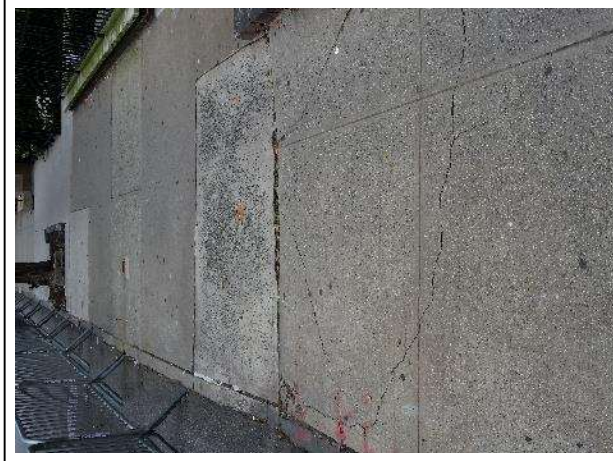
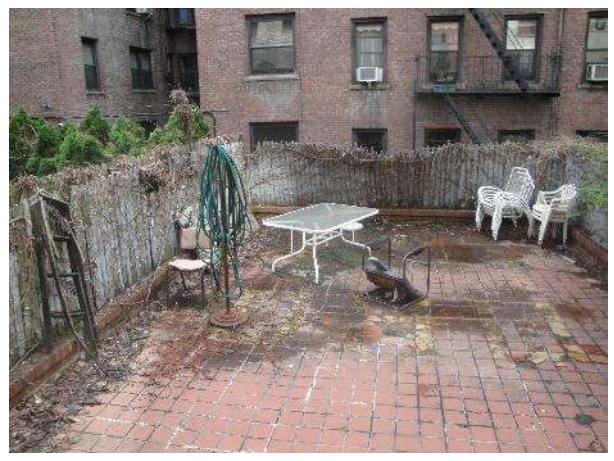
The front (50th) side external wall is painting finished. There are no cracks observed. There are stains observed around window sills and copings. The rear side of the external wall is exposed brick. The rear wall is extensively covered with climbing plants.

The concrete walkway outside of the front entrance is damaged, where the AU is requested to maintain. Both the front and back patios are paved with tiles which are in fair condition requiring cleaning and grouting. The third floor rear patio is finished with asphalt membrane and seems to be in good shape requiring cleaning.

The front guardrail fencing the property from the street and side neighbors is made of metal which has rusted with minor damage on some members. The back patio wooden guard rail is rotten.

The main entrance door is damaged which requires replacement. The door to the back patio is in good condition bur requires maintenance.

- Patch the cracked external city concrete pedestrian walkway as per the standards of the city. The specification of concrete, procedure and finishing quality shall meet the city standards.

- Repair grout joints of the front and back yards paved with 4x4 tiles. Work includes deep cleaning of the floor tiles to remove stains using spin scrubber machine and approved type chemical.

- Repair the metal guardrail/fence. Works include welding of disconnected members, replacement of missing members and spray painting with approved type paint.

- Back Yard guardrail (option 1): repair wooden guardrails. Work includes replacing highly damaged and missing members, realignment, sanding and spray painting with approved paint.

- Back Yard guardrail (option 2): replace the wooden backyard wooden guardrails with approved type PVC Guardrails of similar height and pattern. Work includes cart away of removed wooden rails.

- Clean the painted front facade to remove heavy soiling and stains including window sill sand stone copings.
- Repair damaged plastering/stucco and paint the front facade with approved type paint.

- Remove climbing plants from the rear exposed brick façade and repoint joints where damaged.
- Main Entrance Door (Option 1): Remove and replace existing main entrance door with similar type door including frame.

- Main Entrance Door (Option 2): Maintain the main entrance door by replacing locks, maintain damaged parts and painting with approved type.
- Inspect for external window leakages and re-caulk identified leakage points.

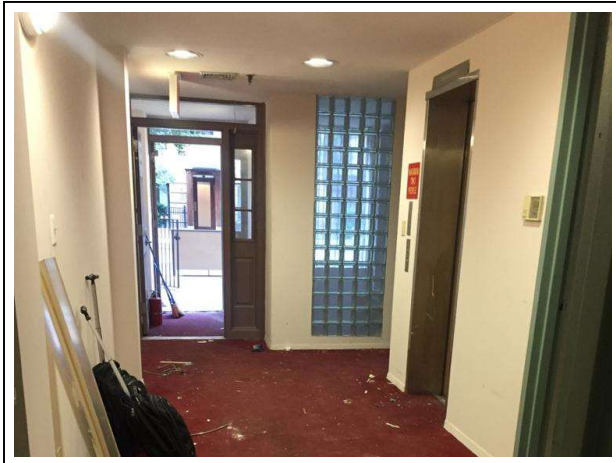
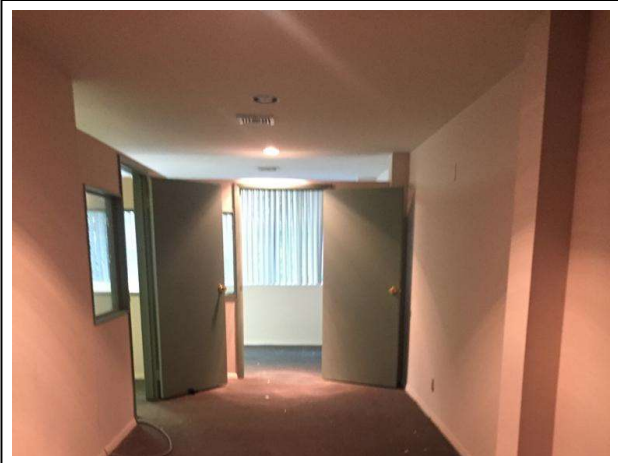
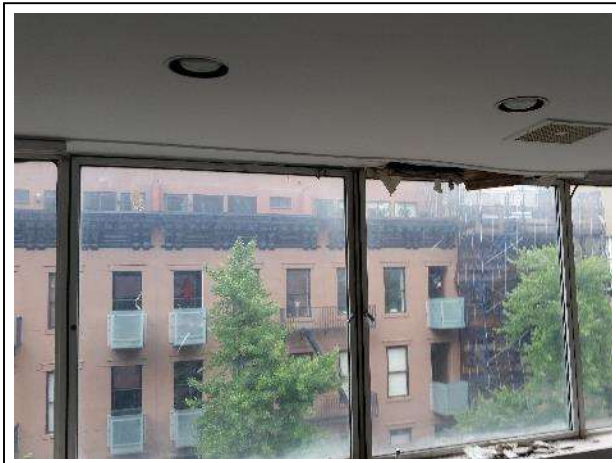
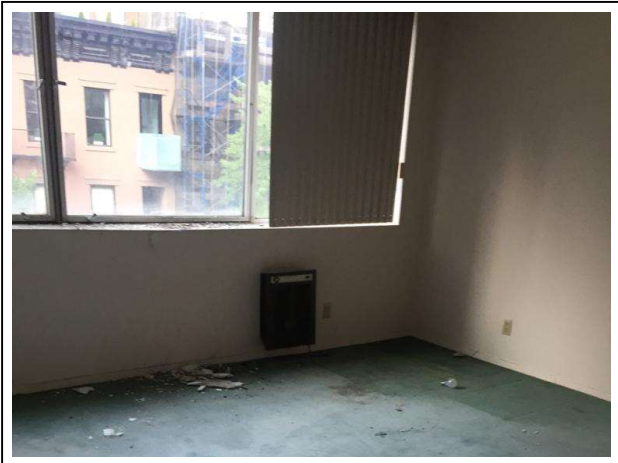
Office spaces are finished with carpet flooring, dry wall ceiling/suspended acoustic ceilings in some areas and painted doors;

Common spaces are finished with carpet flooring, dry wall ceiling and painted doors;

Toilet spaces are finished with ceramic floor, dry wall ceiling and painted doors; The internal finishes are in fair condition at the time of observation.

Another area observed to be highly damaged is the dry wall ceiling at the fifth floor on the front side.

- Carpet floors (option 1): Deep clean existing floor and stair carpets using steam cleaning machine. Shampooing may be applied at areas where stains cannot be remove with steam cleaning.

- Carpet floors (option 2): Remove existing floor and stair carpets and replace with approved new carpet. The new carpet shall meet local standards for commercial use. Work includes removing and fixing back wooden floor skirting. Samples has to be provided for approval.

- Deep clean toilet ceramic tiles and base skirting to remove stains using spin scrubber machine and approved type chemical.
- Inspect all office wall surfaces for damage and repair. Apply a proper coat of approved paint to the areas repaired, as well as any wall surface indicating prior water damage. Match color to existing wall paint.

- Apply proper coat of approved paint with compressor spray to all walls excluding basement wall.
- Apply proper coat of approved paint with compressor spray to all toilet walls.

- Replace damaged ceiling tiles and clean the ceiling runners. Work includes strengthening of the suspension systems of the ceiling tile runners in all offices, hallway and toilets. Clean all suspension frame and runners.
- Repair damaged drywall ceilings and apply a proper coat of approved paint to the areas repaired. Work doesn't include basement floor.
- Apply proper coat of approved paint with compressor spray to all drywall ceilings excluding basement floor ceiling.
- Ensure all doors open smoothly; adjust as needed.
- Replace damaged door knobs and locks.
- Ensure all windows open smoothly; adjust as needed.
- Repairs to window casements with identified damage to stop water leaks and make weather tight by replacement/fixing of rubber seals and/or other application of silicone-based sealants.

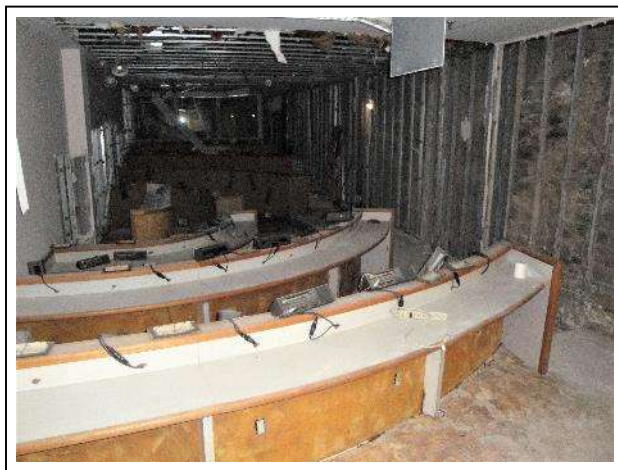
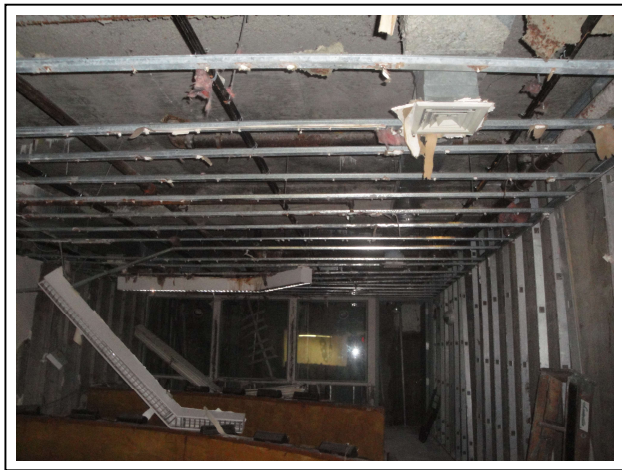
The basement, which served as an assembly hall, is the part mostly damaged during this time due to a flooding as a result of broken water supply line. The flooding damaged the dry walls, fixed furniture and the ceiling. Formation of excessive mold is also observed in the basement floor.

- Dismantle and remove all dry wall and ceilings in the assembly hall and interpretation booths at the rear of the building. Steel studs and ceiling suspension systems are not to be dismantled. Work includes cart away of removed materials.
- Dismantle the fixed tables and furniture in the assembly hall and interpretation booths at the rear of the building. Work includes cart away of removed materials.
- Remove/clean/treat basement mold
- Apply proper coat of white paint on the walls of the basement assembly hall walls.

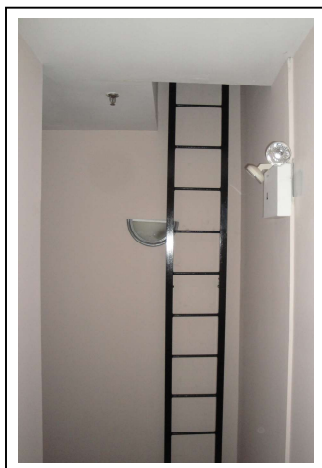
It is observed that there is roof leakage at the front side of the building which damaged the dry wall ceiling. It was not clear if the problem was related with pointing of the coping or damage on concrete water proofing.

- Identify leakage points and apply appropriate water proofing works including pointing of copping.
- Maintain the access latch.

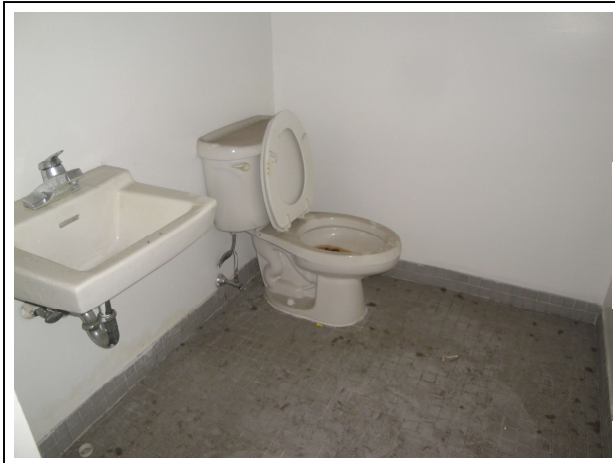
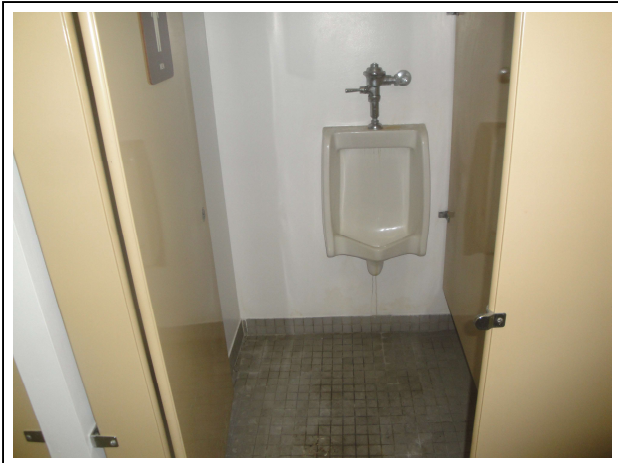
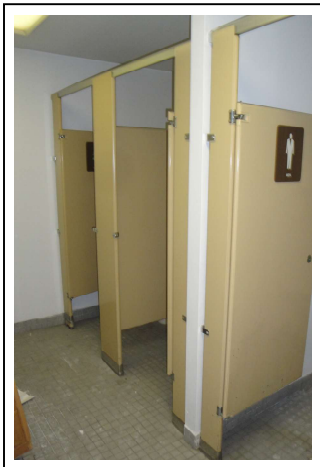
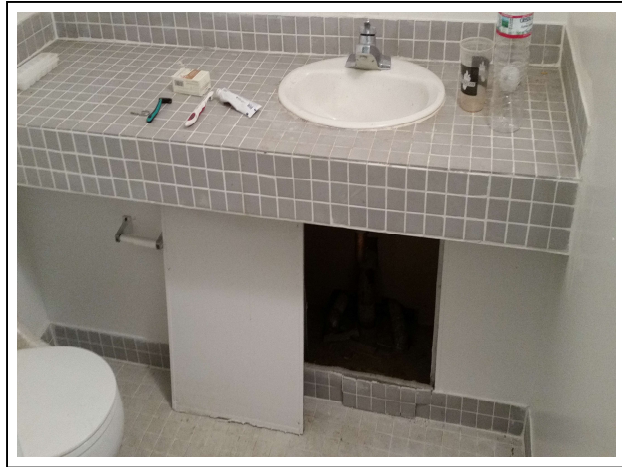
The toilets seats, sinks and urinals are in fair condition mainly requiring deep cleaning. Damaged toilet seat covers and accessories, sink faucets, drains and supply houses shall be replaced.

- Toilet seat (option 1): Deep clean and remove all stains of toilet seats using appropriate and approved bleach. Change seat covers, supply hoses and other defective accessories. Check and test drainage and water supply for proper functioning fix any problem.

- Toilet seat (option 2): Remove and replace toilet seat and all accessories, water supply hoses and seat cover with approved and similar size and standard seat with existing ones. Check and test drainage and water supply functioning and fix any problem.

- Toilet sink (option 1): Deep clean and remove all stains of toilet sinks using appropriate and approved bleach. Change faucet, supply hoses, drain and p-trap and other defective accessories. Check and test drainage and water supply for proper functioning fix any problem. The faucet and p-trap shall be chrome plated and be approved. Work includes cart away of removed seats and items.

- Toilet sink (option 2): Remove and replace existing toilet sinks and all accessories with approved and similar size/standard sink with existing ones. Change faucet, supply hoses, drain and p-trap. Check and test drainage and water supply for proper functioning fix any problem. The faucet and p-trap shall be chrome plated and be approved. Work includes cart away of removed sinks and items.

- Replace the shower head in the 5th floor toilet. Check and test drainage and water supply for proper functioning fix any problem.
- Fix base of the embedded toilet sink in the 5th floor toilet including the base ceramic skirting.

- Supply and fix toilet paper holders.

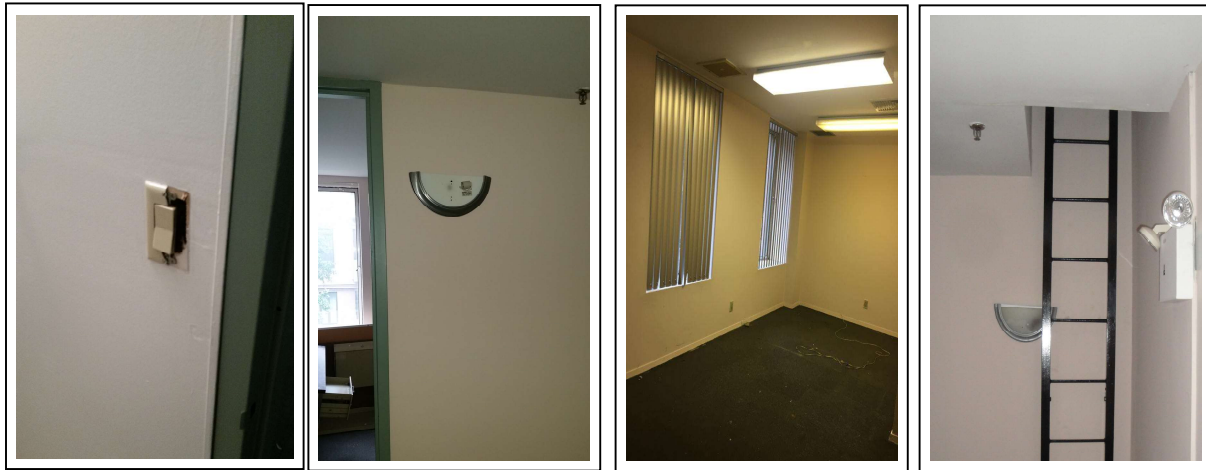
The electrical system seems to be working. Many lights are observed to be burnt out and broken. There are also broken light switches and socket outlets. The entire electrical system requires inspection and testing. The main distribution switch is located in the basement.

- Inspection and testing by certified professional of the overall electrical system and telephone line installation and operation for correct functioning in accordance with local standards and identify any existing safety hazards. Rectify any identified problem including fixing and replacing damaged parts such as breakers, cables etc. Affix a table chart to the inside of the power panel door and label as appropriate to allow proper maintenance. Work include entire system testing, commissioning and issuance of certificate. Report if there are major defects.

- Testing and verification of the existing electrical surface fixtures for correct functioning. Clean all existing working fixtures.
- Repair and replace damaged/non-functioning electrical sockets and switches as per required standards.

- Replace non-functioning recessed light fixtures with similar fixtures as the existing ones.
- Replace non-functioning florescent light fixtures with equivalent LED fixtures

- Replace non-functioning lamps of the recessed fixtures with the same/equivalent type energy saver lamps.
- Replace non-functioning florescent tubes.
- Replace non-functioning emergency lights with approved similar types as existing ones.
- Replace non-functioning emergency exit illumination lights with approved and similar types as existing ones.
